AFTER EARTHQUAKE DAMAGE AND BEHAVIOR OF BUILDINGS IN GJILAN REGION

Abstract. *Various types of structures were assessed after an earthquake that struck Gjilan on April 24th 2002 with a purpose of identifying seismic deficiencies that might impact the general stability of the buildings located within the downtown City. The overall seismic performance goal identified by our team for these buildings is life safety. To achieve this goal, partial collapse of structure and/or of any cladding element that could result in a life safety concern should be prevented during a major earthquake. The largest issue identified is the unreinforced or inadequately reinforced brick masonry construction and those combined with skeletal, particularly buildings with soft ground stories all located along and at both sides of the main avenue. Based on our study, recommendations were given in whether saving some of the building would be feasible, since any attempt on this, especially for those constructed after the Second World War, would be costly. The newer one, (i.e. those constructed after the mid 1970's) should easily perform at a life safety level and meet the local performance goals). Earthquake for

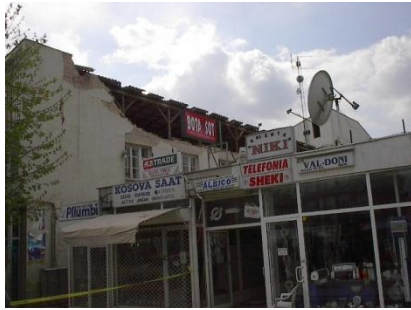
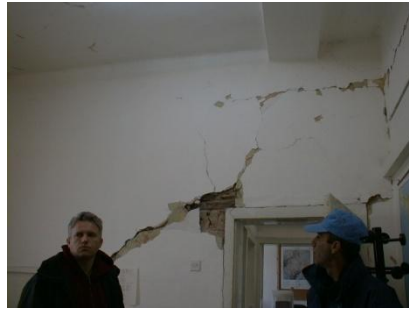
Initially following the earthquake, there were major damages found to the City Hall serving to UNMIK Administration at Gjilan centre. This structure, built in 1950 suffered significant damage to its brick façade, particularly near the roof line of the building as well as significant cracking in the walls made of burnt clay bricks with a random bonding throughout the building and considerable contents damage to display cases in the lobby. To a higher extent damage was found on rubble wall (opus incertum) at the east wing of this U shape building. The old Municipal building was red-tagged within 24 hours of the event.

Figure 2 & 3 North side of the Municipal Building with the attic wall fallen down and interior wall damage

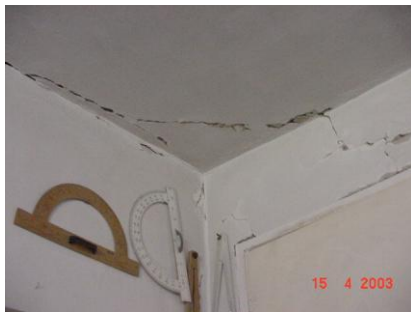
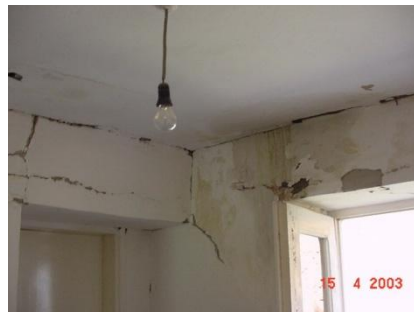
In rural areas, low-cost school buildings are generally constructed by the state government using stone masonry with mud mortar. Several such buildings suffered severe damage due to the earthquake event.

No earthquake-resistant features such as horizontal bands at various levels nor tying stones at the corners are found in such constructions. This resulted in the formation of severe cracks near the corners and at the location of openings when subject to these although mild shaking (Figure 4).

Figure 4 & 5 Typical damage of the school structure Kremenata – Kamenica

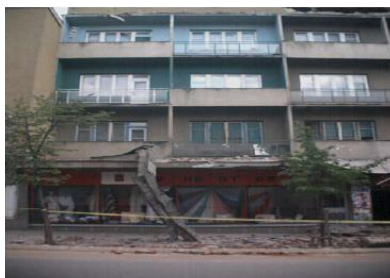
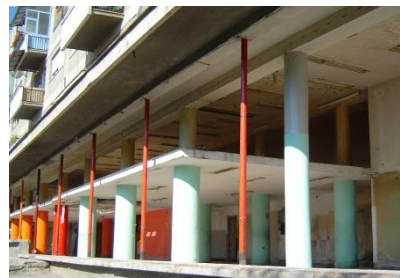
- ii. All along the main avenue there are often encountered cases of four to six storey buildings in which the lowest level is significantly weaker than the others; some are quite open, with columns supporting the upper stories and with no walls on ground level. Such cases are known as soft stories, and are highly prone to collapse. Another disadvantage of these structures is the fact that all of them are made of thick clay brick walls above contributing in this way to the increase of mass concentrated on the upper floors.

There are also examples where conversion of the ground floor of a building into a restaurant or shop had weakened it (creating a soft storey); subsequent construction on an extension to the existing building that had likely made the ground plan more irregular, and introduced irregularities of stiffness and period within the overall structure. There are also old masonry buildings that have been extensively modified over a long history, resulting in offsets of floors at different levels, foundations at different levels, and so on. It was relatively easy to identify gross irregularities within the mix use buildings located along the main avenue, trade + residential; for example, buildings with ground plans designed as an L shape or similar are often encountered and are subject to torsional effects which may have greatly increased the damage suffered.

Figure 6 & 7 Collapsed attic wall fallen down from roof of mix use building & Intervention on the soft story of five story structure, actual Raiffaisen Bank building

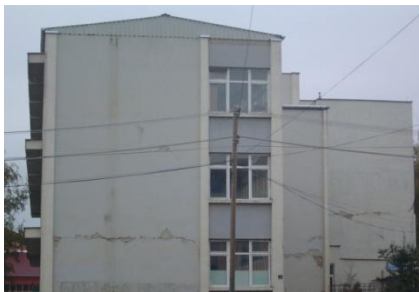
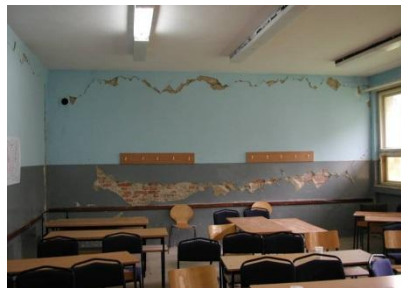
RC-frame buildings with masonry infill are mostly used in private as well as government constructions. The application of adequate formal design practices in Region even for RC-frame buildings started only after 1970s. Before this, except for a few RC buildings involving major projects, analysis and design were generally not carried out in details; structural drawings seemed to have been prepared simply based on previous experiences of engineers. Some of the new RC buildings, mainly not engineered suffered varying degree of damage during this earthquake; however there were sporadic and mainly of non-structural elements damages encountered at institutional RC buildings.

Figure 8 & 9 Non-structural damage of infill walls at high school Arberia, Gjilan

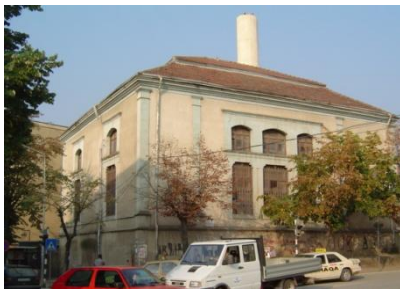
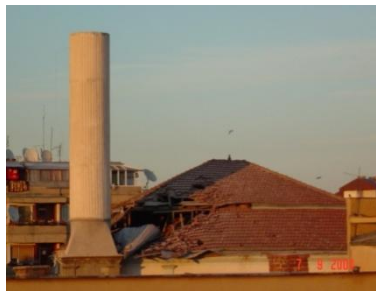
The other worst damage and perhaps due to its complexity of structural and non structural composition that made it likely prone to damages was to the historic Mosque at the downtown centre of the city. This building dating from the early 1900s and listed on the National Register of Monuments suffered severe serious damage. The un-reinforced brick masonry structure of minaret collapsed and fell out-of-plane causing so serious damage to the roof and to its central dome, and the top reinforced concrete perimeter belt and the bearing peripheral walls cracked heavily. Unfortunately, due to careless approach of respective institutions this unique and important element of the cultural heritage of the city, three year later was completely demolished. Minor to moderate damages were also found to the church and other mosques within the city but fortunately enough they all survived.

Figure 10 & 11 City Mosque encountered serious structural damage & collapsed minaret over its roof (pictures taken two years after the earthquake incident)
