AFTER EARTHQUAKE DAMAGE AND BEHAVIOR OF BUILDINGS IN GJILAN REGION

Abstract. *Various types of structures were assessed after an earthquake that struck Gjilan on April 24th 2002 with a purpose of identifying seismic deficiencies that might impact the general stability of the buildings located within the downtown City. The overall seismic performance goal identified by our team for these buildings is life safety. To achieve this goal, partial collapse of structure and/or of any cladding element that could result in a life safety concern should be prevented during a major earthquake. The largest issue identified is the unreinforced or inadequately reinforced brick masonry construction and those combined with skeletal, particularly buildings with soft ground stories all located along and at both sides of the main avenue. Based on our study, recommendations were given in whether saving some of the building would be feasible, since any attempt on this, especially for those constructed after the Second World War, would be costly. The newer one, (i.e. those constructed after the mid 1970's) should easily perform at a life safety level and meet the local performance goals). Earthquake for

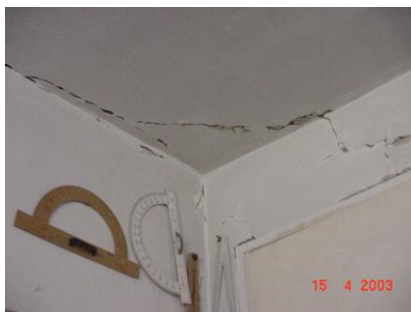
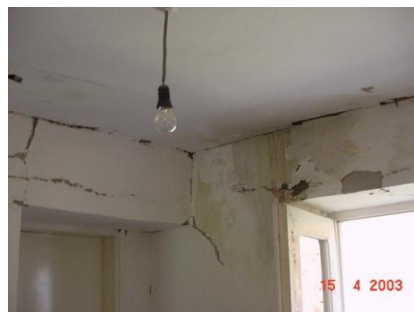
In rural areas, low-cost school buildings are generally constructed by the state government using stone masonry with mud mortar. Several such buildings suffered severe damage due to the earthquake event.

No earthquake-resistant features such as horizontal bands at various levels nor tying stones at the corners are found in such constructions. This resulted in the formation of severe cracks near the corners and at the location of openings when subject to these although mild shaking (Figure 4).

Figure 4 & 5 Typical damage of the school structure Kremenata – Kamenica

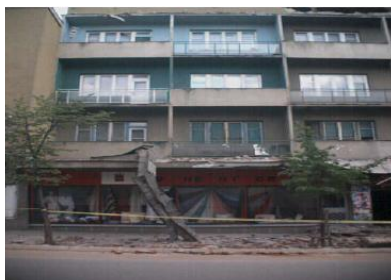
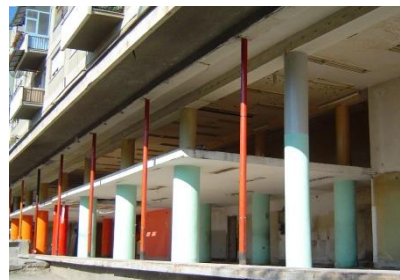
- ii. All along the main avenue there are often encountered cases of four to six storey buildings in which the lowest level is significantly weaker than the others; some are quite open, with columns supporting the upper stories and with no walls on ground level. Such cases are known as soft stories, and are highly prone to collapse. Another disadvantage of these structures is the fact that all of them are made of thick clay brick walls above contributing in this way to the increase of mass concentrated on the upper floors.

There are also examples where conversion of the ground floor of a building into a restaurant or shop had weakened it (creating a soft storey); subsequent construction on an extension to the existing building that had likely made the ground plan more irregular, and introduced irregularities of stiffness and period within the overall structure. There are also old masonry buildings that have been extensively modified over a long history, resulting in offsets of floors at different levels, foundations at different levels, and so on. It was relatively easy to identify gross irregularities within the mix use buildings located along the main avenue, trade + residential; for example, buildings with ground plans designed as an L shape or similar are often encountered and are subject to torsional effects which may have greatly increased the damage suffered.

Figure 6 & 7 Collapsed attic wall fallen down from roof of mix use building & Intervention on the soft story of five story structure, actual Raiffaisen Bank building

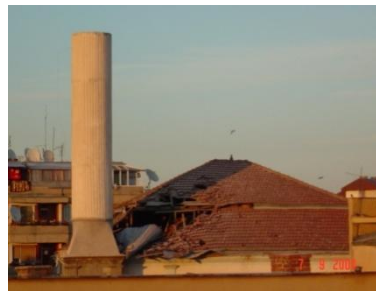
The other worst damage and perhaps due to its complexity of structural and non structural composition that made it likely prone to damages was to the historic Mosque at the downtown centre of the city. This building dating from the early 1900s and listed on the National Register of Monuments suffered severe serious damage. The un-reinforced brick masonry structure of minaret collapsed and fell out-of-plane causing so serious damage to the roof and to its central dome, and the top reinforced concrete perimeter belt and the bearing peripheral walls cracked heavily. Unfortunately, due to careless approach of respective institutions this unique and important element of the cultural heritage of the city, three year later was completely demolished. Minor to moderate damages were also found to the church and other mosques within the city but fortunately enough they all survived.

Figure 10 & 11 City Mosque encountered serious structural damage & collapsed minaret over its roof (pictures taken two years after the earthquake incident)
