Structural Investigations for the Refurbishment Project of the Municipal Building of Gjakova

Abstract. This paper presents the structural investigations performed on the existing municipal building of Gjakova, intended to be refurbished as part of the Refurbishment project by the European Commission. The municipal building of Gjakova built in the end of 1960s is a reinforced concrete structure with bearing masonry walls which are scattered without any logical pattern. This structural system presents a difficult approach for the seismic assessment of this building. To obtain the confidence factors and the mechanical parameters for the appropriate numerical modeling, a series of structural investigations is carried out in detail. Initially a visual inspection is conducted, and a photographic survey is carried out with a detailed marking of each picture to visualize the building and plan the detailed inspection. The detailed plan is organized according to the gathered information and the existing documentation, so that maximal information about the structure is acquired with the minimal possible intrusiveness. The detailed inspection is accomplished in a series of frequent site visit

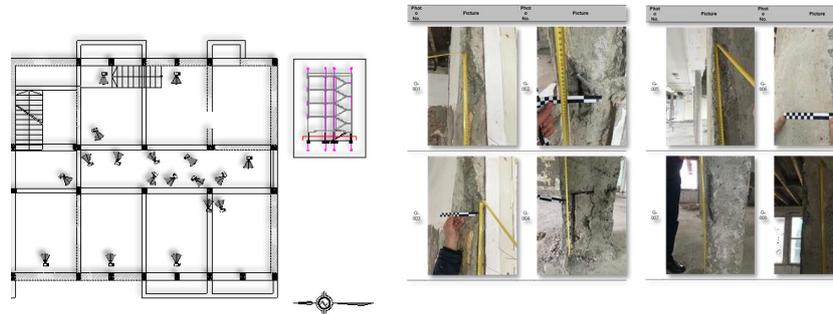
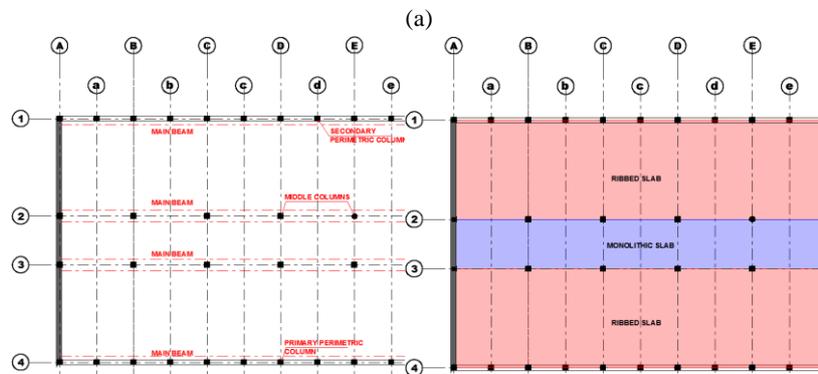
A preliminary inspection was carried out in the structure to perform a qualitative investigation in order to obtain information about the structural system, the actual damages and decide on the testing to be performed on the structure. Initially, original drawings from the archive were analyzed and then processed and regenerated into CAD drawings. A detailed geometrical survey was required to verify the existing structure to the original drawings. New and more detailed drawings of the existing situation were created with the geometrical in-situ data obtained. The geometrical survey was complemented with a photographic survey which was also mapped in the drawings (Fig. 3-a). The photographic survey included the documentation of the different damages in the structure. The damages were additionally gathered in a table where their nature and severity were categorized to have a better understanding. A major number of serious damages were found in the structure including structural

Fig. 3. (a) Example of the photographic survey and mapping on the drawings; (b) Structural system of the existing building; cracks, spalling and pop-outs of the concrete, extensive segregation, corrosion and exposed rebars, misalignments, warping, rebar buckling and installations going through the structural members and so on, where some can be seen in Fig. 3 (a). The structural system of the building can be seen in Fig. 3 (b), where the vertical bearing system consists of reinforced concrete (RC) columns in the middle and perimeter whereas on the lateral sides and for the stairs core structural masonry is observed, thus creating a mixed structure. The horizontal bearing system is made of a combination of monolithic RC slabs in the mid-span and RC ribbed slabs on the sides, all supported in RC beams which go only in the longitudinal direction of the building. The foundations consist of RC isolated footings for the mid-columns and RC strip foundations for the perimeter columns and walls with no tie beams to connect them.

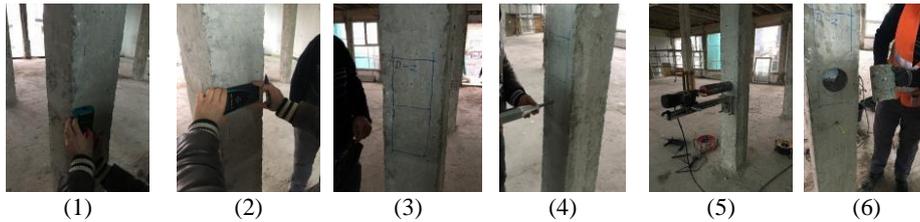
concrete samples, but due to the fragility of the structure only 4 cores were taken, namely 3 columns and 1 beam. The core sampling procedure shown in Fig. 4 followed the localization of the rebars with a profoscope (1,2), surface preparation with abrasive stone (3), 9 rebound hammer readings in the coring location (4), fixation of the core drilling machine (5) and then the coring of a 10 cm diameter concrete sample with no reinforcement inside (6).

Fig. 4. Core sampling procedure;

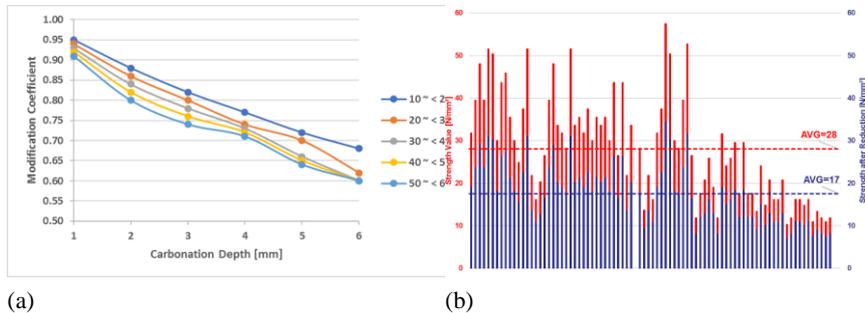
The concrete compressive strength in-situ conform [3] can be obtained by correlating the NDT results with results from DT of cores. Initially the NDT results from the rebound hammer readings are reduced depending on the carbonation results of the cores. The average carbonation depth in the samples was found to be 27.5 mm, which is a relatively high value. The reduction values (Fig. 5-a) are given by a modification coefficient which multiplies the rebound hammer reading depending on the detected strength in MPa. It can be seen that the theoretical value for 27.5 of carbonation reaches a modification coefficient of zero, but for practical reasons readings are done for 6 mm of carbonation. The rebound hammer readings are shown in Fig. 5 (b), where can be observed the reduction of the average compressive strength from 28 N/mm² to 17 N/mm².

Fig. 5. (a) Carbonation reduction factor according to strength detected; (b) Strength readings from rebound hammer and after reduction;

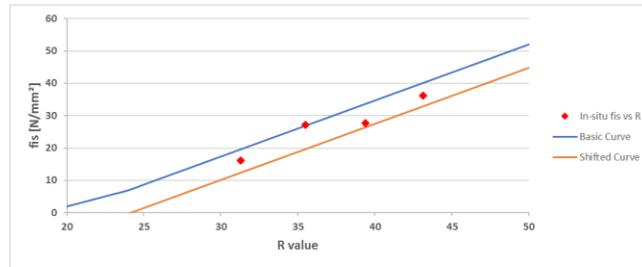
Following the procedure in [3], the correlation values are obtained by initially forming a basic curve and then shifting it as per the test results from the in-situ cores and the rebound readings. The final curve obtained, which correlates the rebound hammer readings to the in-situ compressive strength, is shown in orange in Fig. 6.

Fig. 6. The curve correlating rebound readings to the in-situ compressive strength; The characteristic compressive strength of the concrete, which is directly related to the concrete class, is then obtained from the expressions available in the standard and the correlated values from the graph in Fig. 6. The characteristic compressive strengths are found to be 13.22 N/mm² and 17.78 N/mm² for the columns and the beams, respectively. A normal distribution of the compressive strengths for the columns and the beams which resulted from the graph above is shown in Fig. 7. It can be easily observed that the characteristic compressive strength values are at about 5% area that defines the characteristic compressive strength.

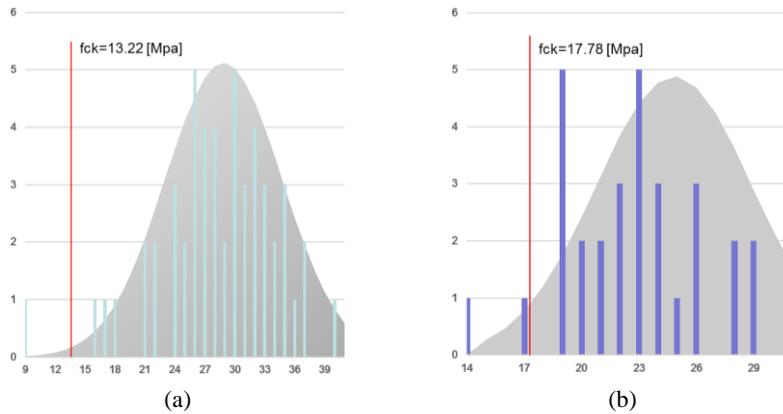
Fig. 7. Normal distribution of the compressive strengths for (a) columns and (b) beams; From these relations it can be concluded that the concrete class for columns can be set as C12/15 and for the beams C16/20, which are way lower than the classes foreseen in the initial original design. The results for the steel samples are shown below in Table 2 and it can be seen that the class can be set to the original steel class of the design which was S 240/360 and be on the safer side.
