Damage observed in structures of different types during the inspection after the Durrës earthquake of 26.11.2019 and proposals for their repair

Arsim Rapuca*, Naim Munishi

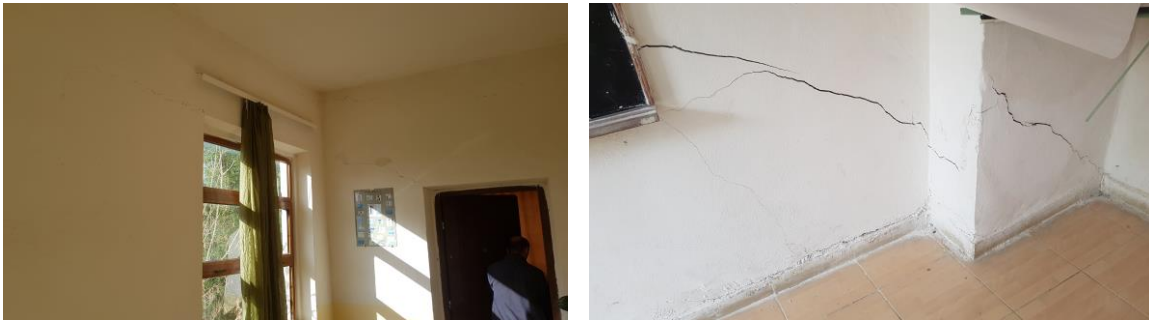
Inspected schools structures in the area of Lushnja and Divjaka were built in old times and mainly with construction systems known for that time, such as rigid system with masonry walls. As it is known at the time when these structures were built the seismic design code was not considered or little considered, also these building systems are structures with low ductility and not suitable for seismic areas. Some of the damages observed during the inspection of these structures were: diagonal cracks in the openings, cracks in the corners where the walls are connected to each other and disconnection between the ceiling structure and the masonry walls.

Figure 1. Damages to the school of Karbunare and Hysgjokaj of Lushnja

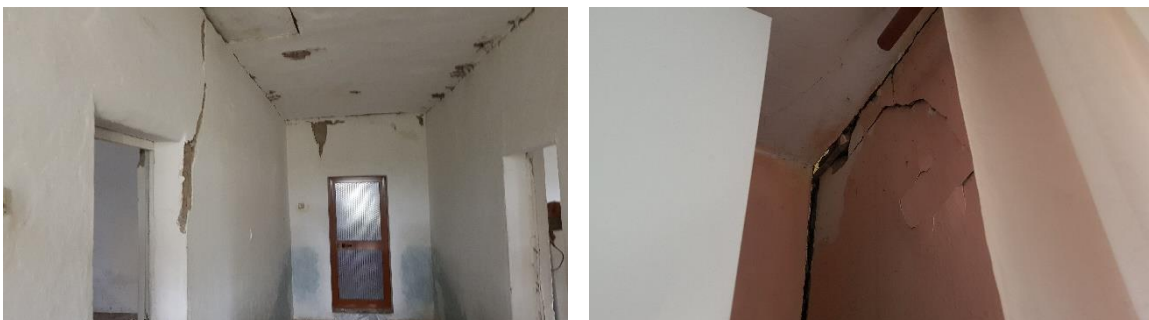
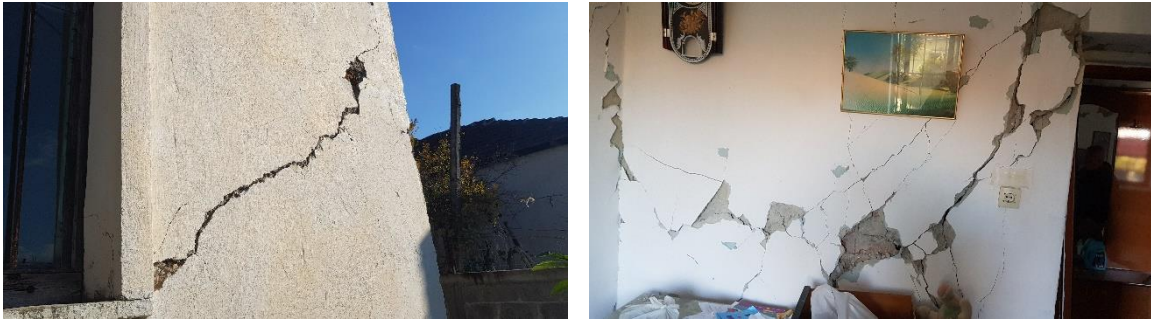
During the inspection in the village of Bushnesh in the area of Thumana, Thuks i ri, IV zone of Durrës and some coastal areas, various structural construction systems were encountered, such as those with rigid masonry wall structures, systems combined with reinforced concrete and masonry walls, as well as flexible reinforced concrete systems. The height of these inspected residential buildings was from those with only ground floor to those with B + P + 4 storeys. The structure of the single-storey houses was built of stone foundations, masonry of bricks, ceilings of wooden elements and plank fillings, as well as the roof of the wooden structure; while the tiles in the buildings with masonry structure with larger floors were made of reinforced concrete reinforced concrete. Some of type of damages observed in these types of structures were: large diagonal cracks in the masonry walls mainly at the corner connections, in-plane diagonal shear cracks of spandrel panels, vertical overturning due to lack of roof-to-wall connection, etc. These damages are mainly due to the construction system which does not withstand the earthquakes loads taking into account the characteristics of the material used as well as the construction method. Figure 2 shows some of the damage observed during inspections.

Figure 2. Damages of residential buildings with masonry walls structural system

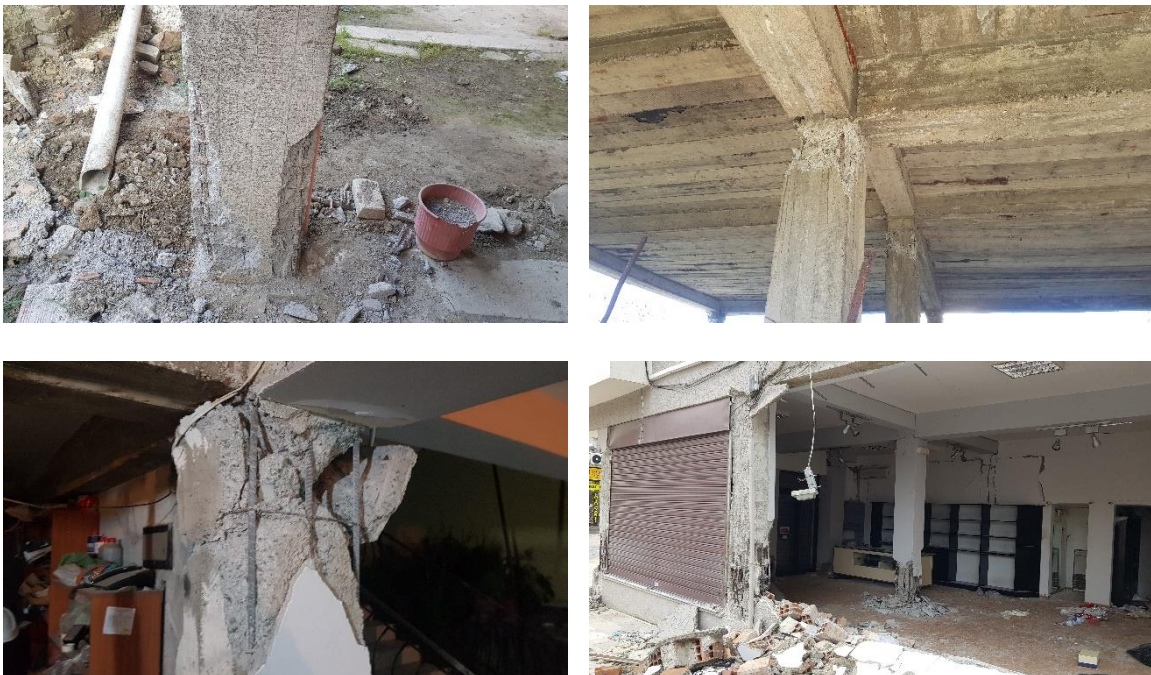
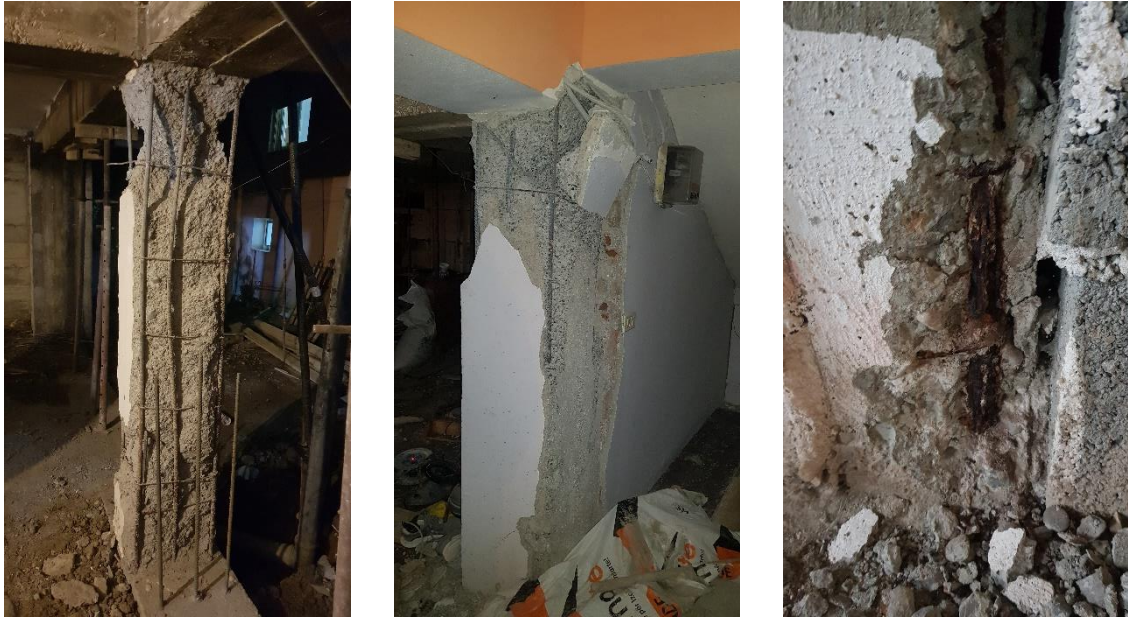
The structures of the inspected houses in the area of the Thuks i ri of Durrës zone were built with rigid masonry construction systems (stone foundations, brick masonry walls, wooden ceilings or concrete slabs), combined structure from reinforced concrete and brick masonry, and flexible reinforced concrete structure. The storeys of these houses were different, such as: ground floor only (GF + 0), GF + 1, GF + 2, B + GF + 1 and B + GF + 2 storeys. Some of the damages observed in the rigid masonry wall systems were large cracks in the masonry walls, mainly at the connections walls at the corners, at the door and window openings, as well as a detachment of the ceiling structure with the vertical masonry wall structure. Some of the damages observed in flexible systems were cracks in the ground columns and removal of the protective layer of the reinforcement, diagonal cracking in the masonry fills between the openings, out-of plane of masonry infill walls, etc. Figure 3 below shows some cases of damages of residential buildings with flexible structural system, especially damages in ground floor.

Figure 3. Damages of residential buildings with flexible structural system in IV zone of Durrës

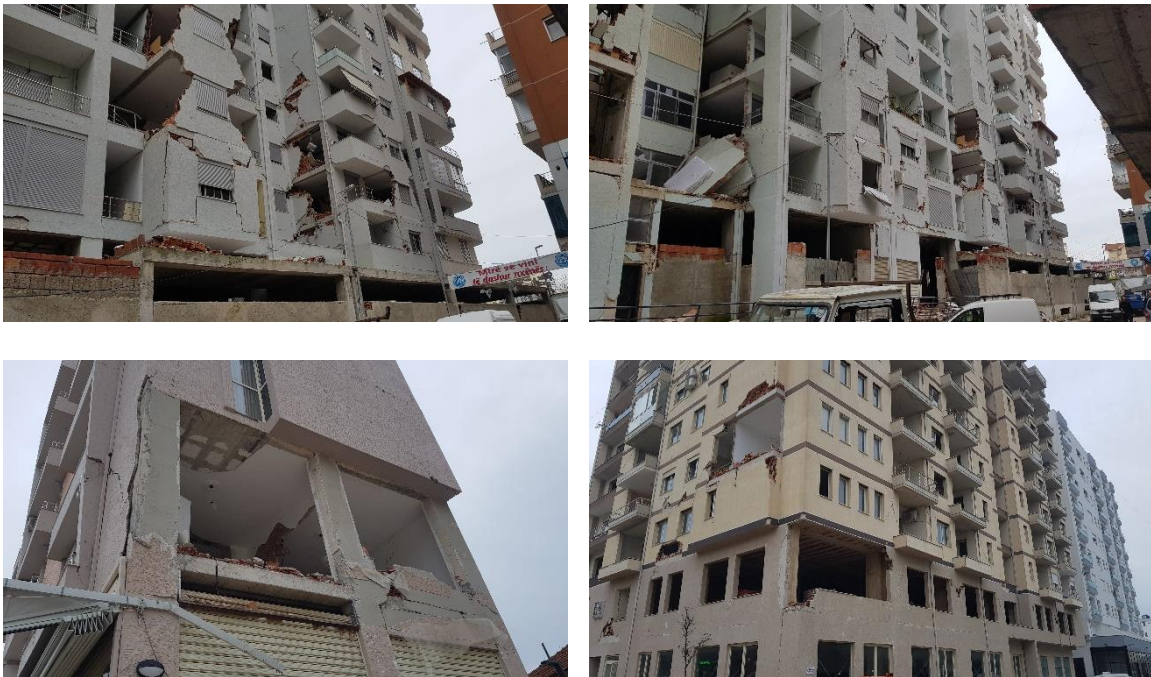
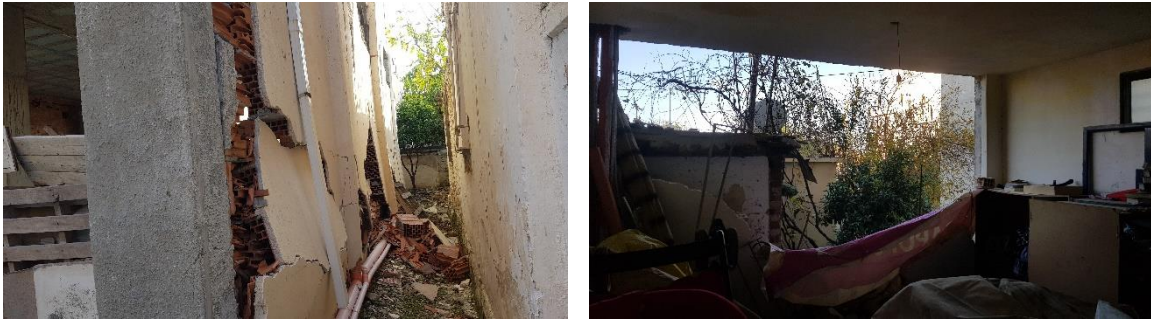
In addition to structural defects, during inspections in the mentioned areas, large damages were observed in the non-structural elements of residential buildings. Masonry wall fillings in many of the structures have cracked a lot and many of them have fallen from the buildings. These major damages have occurred as a result of poor execution of these walls, such as: non-application of reinforced concrete rings due to their height, poor connection of walls at their corners, or in certain cases non-application of tie columns, etc. Figure 4 below shows some cases of large cracks in the masonry fills as well as their falling from the building structure.

Figure 4. Failure of infill walls of residential structures.
