The general energy audit in a primary school in Pristina - a case study

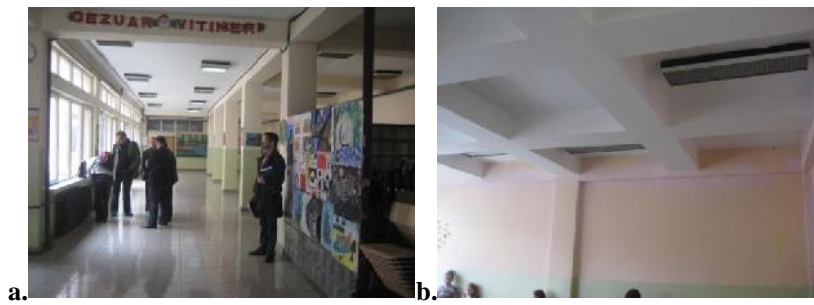
Cover object: Cover or exterior walls have openings - windows. As shown in Figure 1.a, most of the surface of the mantle is composed of windows.

The walls are built with clay bricks, Giter type with holes and continue plastered with loops on both sides, from outside and inside. The windows and doors were replaced in 2006. Plastic windows are double glazed with vacuum 2 [cm] by manufacturer "LESNA". Profile of the window is $d = 7$ [cm] Windows as well as doors are in very good condition and usable. Entresol structure (floor and ceiling): The floor was renovated in 2006. Through the office is laid laminate and ceramic tiles in corridors, figure 1[1].

Fig. 1 View of the interior of the school building: **a.** mainly with windows wrapping and **b.** mid-floor roof from reinforced concrete

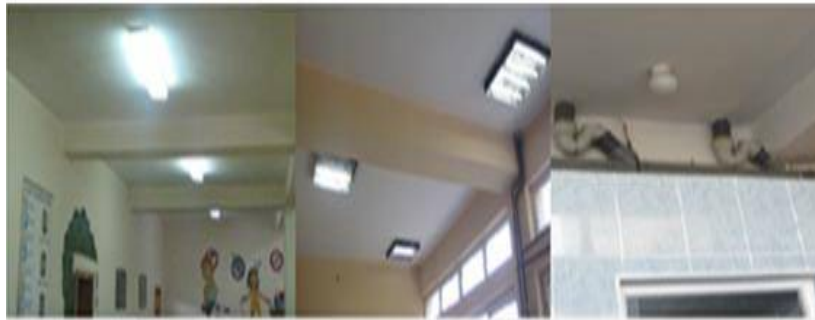
In the corridors, in the classrooms, administrative spaces and other working spaces are located 2×36 [W] fluorescent lamps and 4×18 [W], while the bathrooms and carpeted spaces are located 1×100 [W] incandescent lamps.

Fig. 2 Interior view of school lighting

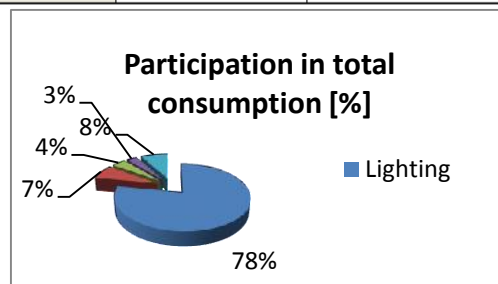
Based on Table 1 and 2 and in Figure 3 shows that the total consumption for lighting and consumed just based on that fact as a measure to be taken to economize energy consumption in lighting, should be replacement of incandescent bulbs with lamps compact fluorescent. **Table 2** Participation in total consumption:

Fig. 3 Participation in the total consumption in %

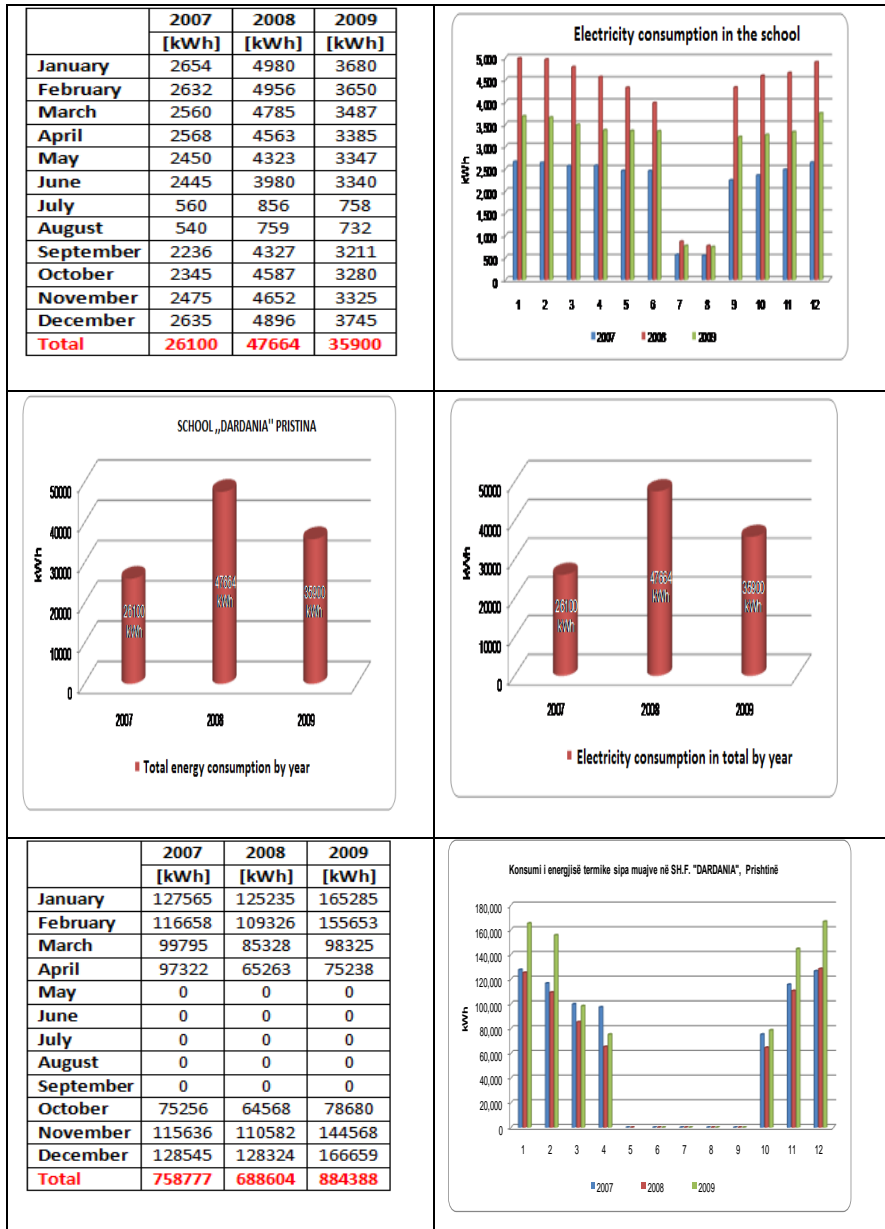
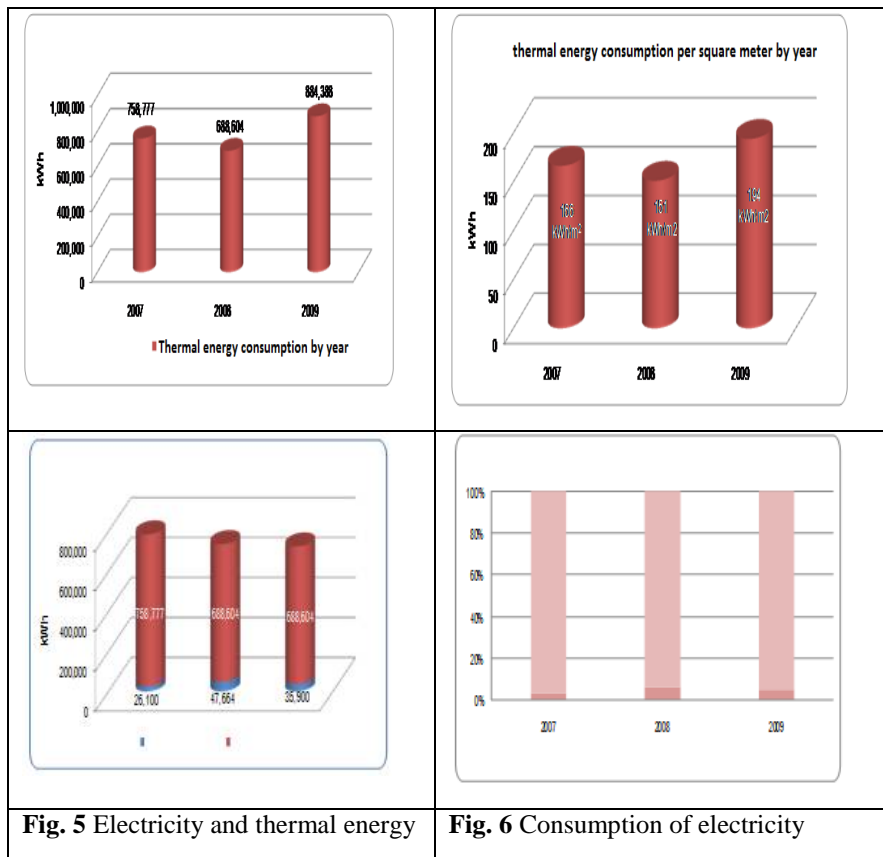
Table 3 shows electricity consumption by month for the past three years. If consumption seen in July and August, shows that different from other months. Because in these months is yearly holiday.

The figure indicates that consumption in 2008 was about 83 [%] higher than consumption in 2007 to the fact that the learning process was held in 2008 with three shifts: [2]. In Figure 6 is presented the consumption of electricity per square meter. Electricity consumption per square meter is quite small. Figure 6 shows that the minimum electricity consumption is spent, but it does not mean that influenced the pupils comfort. The school also has a significant generator power from $P=60$ [kW]. On the basis of what was stated above, it was difficult to find yearly production of electricity from the generator. Building thermal energy supplied by the heat Termokos.

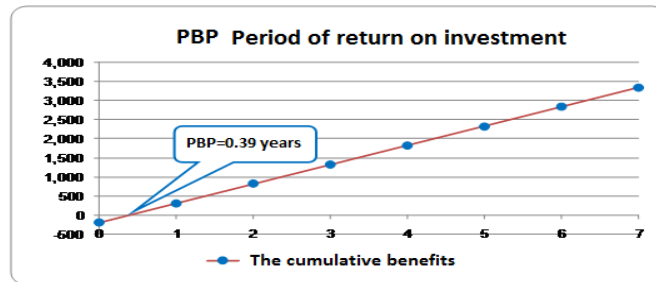
The total investment cost for the replacement of lamps is 196 euro. Lamp operation time is 8000 hours according to the manufacturer and if compared to the operation of lamps in the school that is about 1000 hours, it appears that these lamps will operate about.

Fig. 7 The period of return on investments

- According to Figure 7 and Table 6, the payback period will be for years, and for years it's time operation lamps, always based on the analysis in Table 6 shows that over the years the school will take about 3339 euros, which worth the investment. So based on this analysis, we conclude that the investment in the replacement of lamps is enough profit for the school;
