UBT International Conference

The Surface Distribution of Oil Spills, the Environmental Status of the Visoka Oilfield, Its Rehabilitation Ways: Case Study

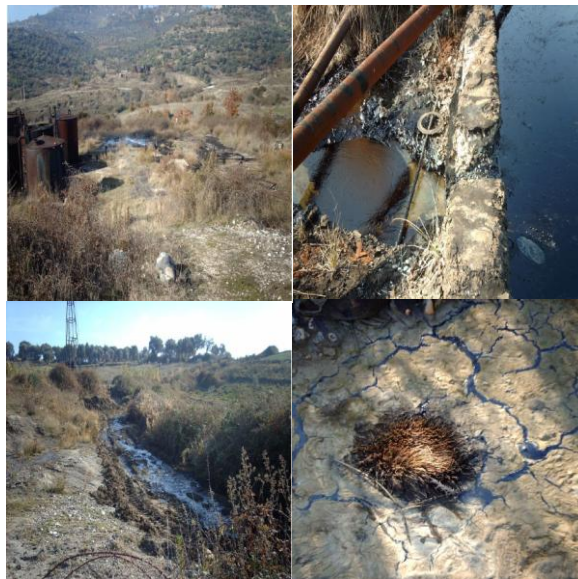
Figure 9: Territory pollution of the Visoka oilfield

Due to the long-time irresponsible exploitation of this oilfield the territory status isn't better than the wells and groups. As the oilfield is placed in the middle of the village the risk is even bigger. In the figure 4 is possible to see the territory pollution of the Visoka village.

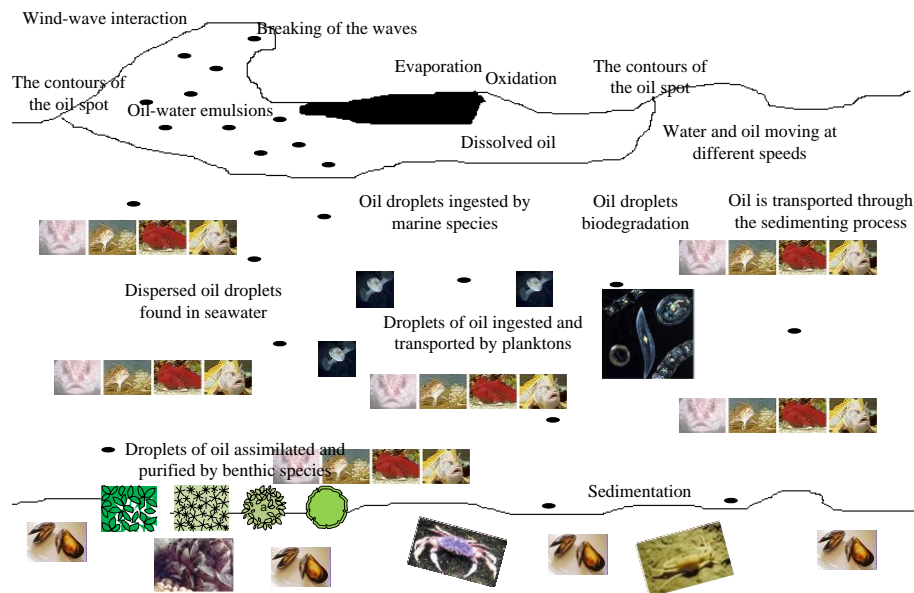
Figure 5: Oil spills processes

Characteristics of oil stains depend on many factors, ranging from the type and properties of the spilled oil, weather conditions, tidal levels and diversity of life living in the polluted area. Although any oil stain has its properties, it's a big mistake to generalize the results achieved by dispersants treatment or mechanically cleaning up. Direction of movement and spreading of oil leak is a natural process but scientifically interpreted. The speed of spread is approx. 3.5÷5% as the average wind speed. It depends also by the tides level in the polluted area. Vector of spread is the resultant vector of these. Its spread is also conditioned by the forces of gravity and oil surface tension. There are also a number of factors whose affect the oil stain spread as evaporation, digestion of light fractions, emulsions, oxidation and biodegradation. The evaporation and light fractions dissolving processes are associated with the emulsions creations. This process is assisted by the added mixtures or chemical transformations that accompany its biodegradation. Although emulsions are created slower than the evaporation and light fractions dissolving, as they change the nature of the spot, the problem is very serious. EIA of an oil stain is a very interesting process, even if the radius of influence is large or small. Binding of the spread in time and space of the spot with the physical, biological and chemical damage of the ecosystem is presented in figure 5.

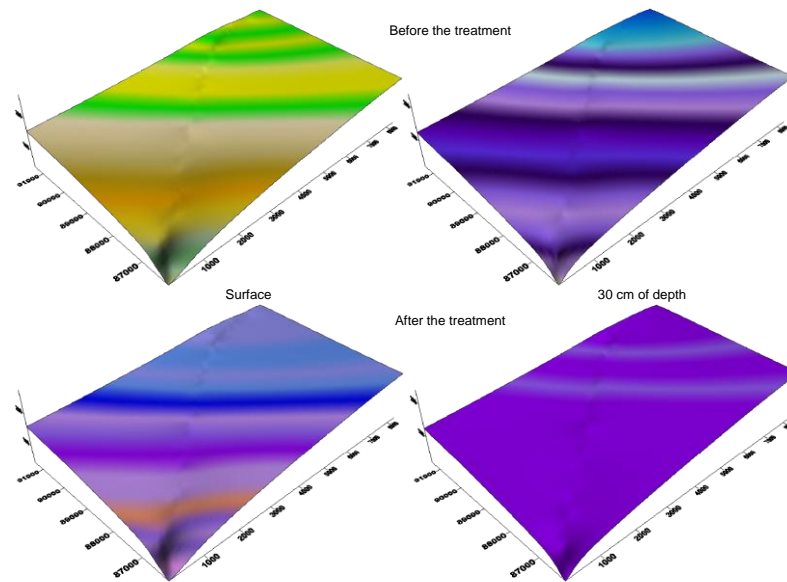
Figure 7: The oil content in the Gjanica river water before and after the treatment

immediate, after only 15 minutes there was no more visible oil in the surface of the water. The monitoring continued based on measurements on two levels: surface and 30 cm depth. The results in both cases were really excellent [10]. The oil content decreased from 0.089 mg/l to 0.008 mg/l at the surface, after 30 min, while they decreased from 0.034 mg/l to 0.002 mg/l at the depth of 30 cm. They are showed also in the figure 7.
